April 30, 2025

Sifton Range Project Number: 2025-138
Via E-mail: Larisse.McDonald@Yukon.ca

Subject: REPORT – Pre-Renovation Hazardous Building Materials Assessment
Christ the King Elementary School, Whitehorse, Yukon

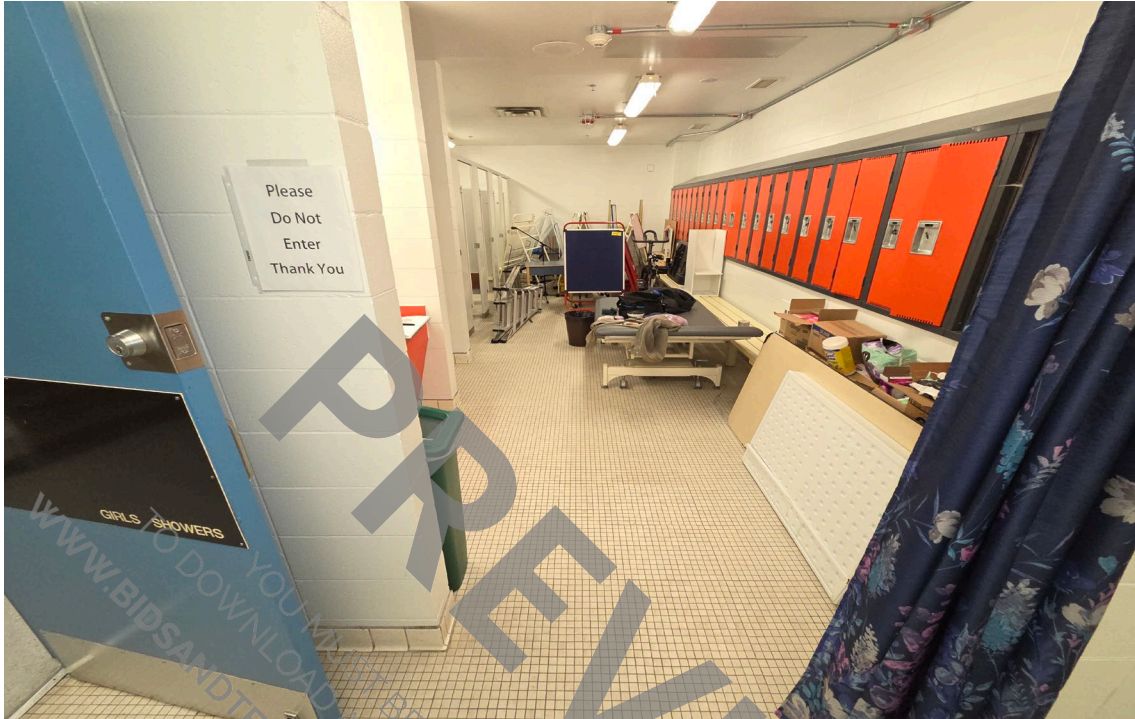
Photo 1: Christ the King Elementary School change room.

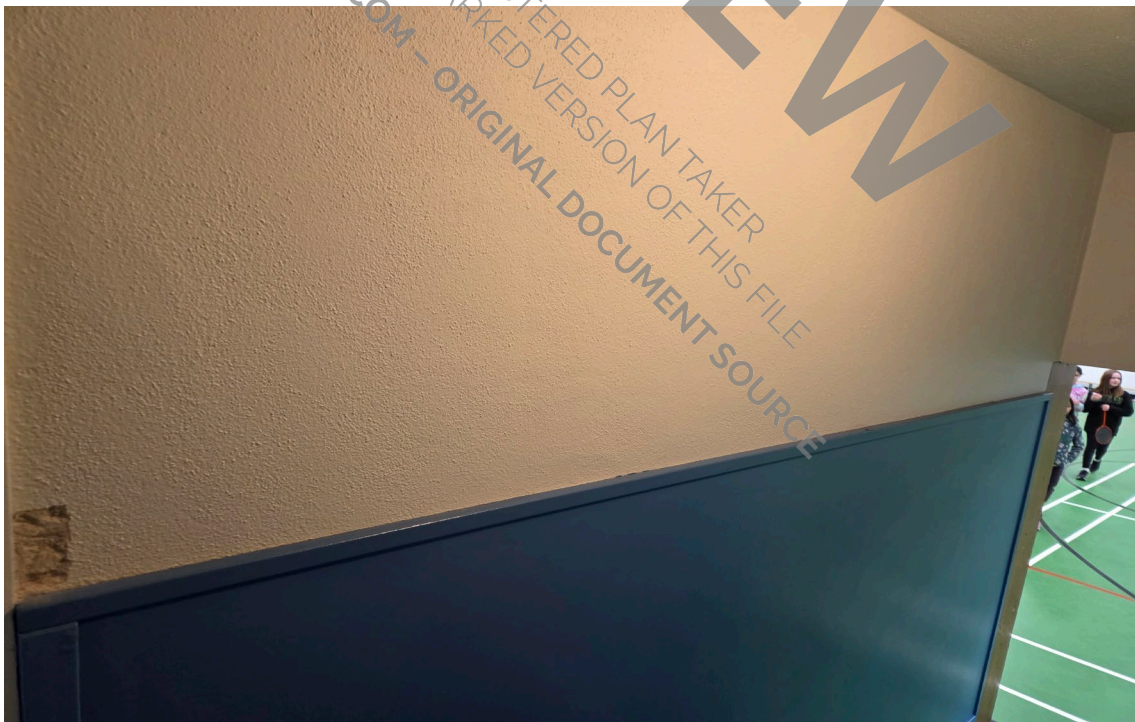
Sample Identifier	ACM Location	Material Type	Percentage of Asbestos	Condition
4-SC-001B	East stairwell	Skim coat on gypsum board	2% Chrysotile	Good

Three samples of drywall joint compound and texture coat associated with the stairwell were collected. One sample was analytically determined to **CONTAIN** asbestos.

Photo 2: Location of east stairwell with asbestos containing skim coat/joint compound.

1. Asbestos containing materials were identified at the time of assessment as follows.
 - a. Skim coat applied to gypsum board associated with the east gymnasium stairwell. If the ACM requires abatement based on project requirements, it should be abated following enhanced moderate risk safe work procedures where controls are put in place to minimize dust migration from the enclosure. As the material is non-friable if not disturbed, the potential for fiber release is low, the risk to building occupants is considered low, therefore the ACM can be managed in place if abatement is not required.

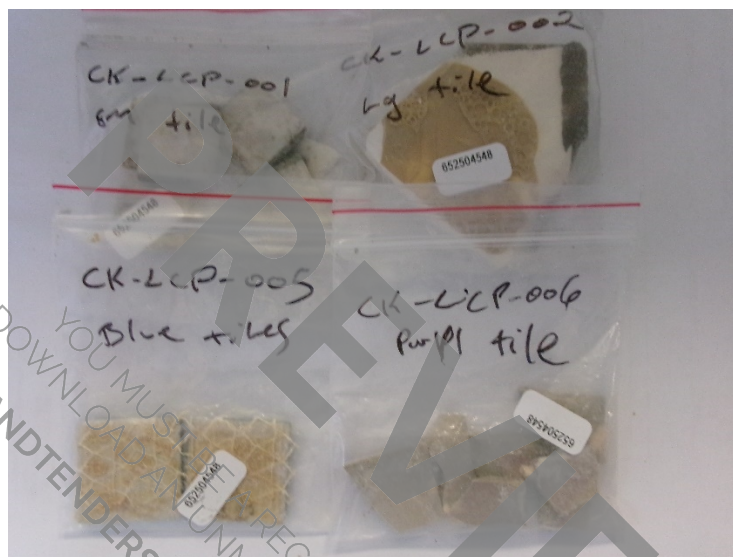
Figure 1. Image of the as-received sample.
